# **Final Third Five-Year Review Report**

**Luke Air Force Base, Arizona**

**July 2012**

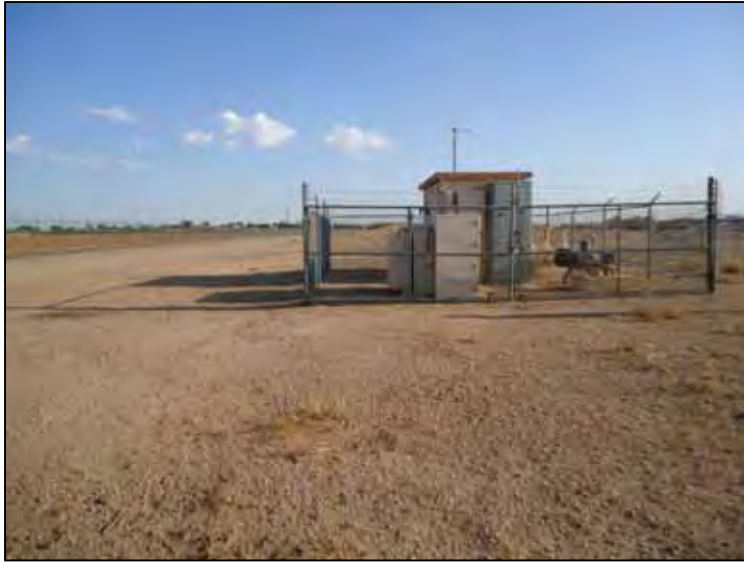
DP-13: Abandoned well at south end of site

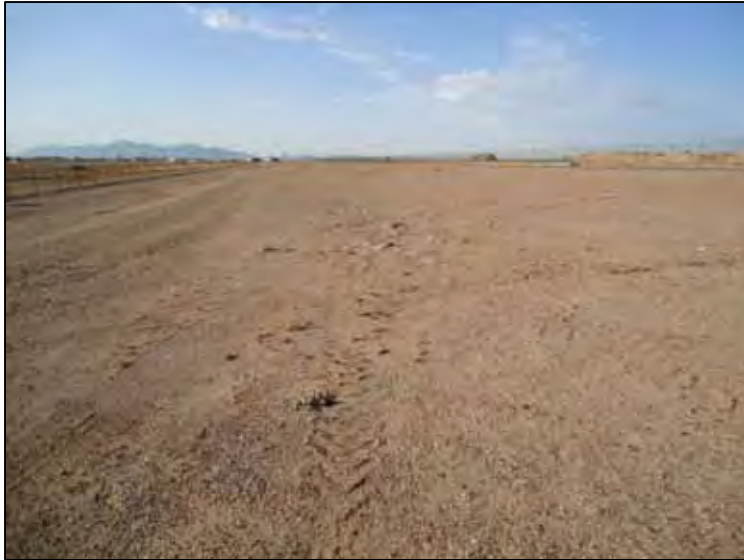
DP-13: At south end looking north

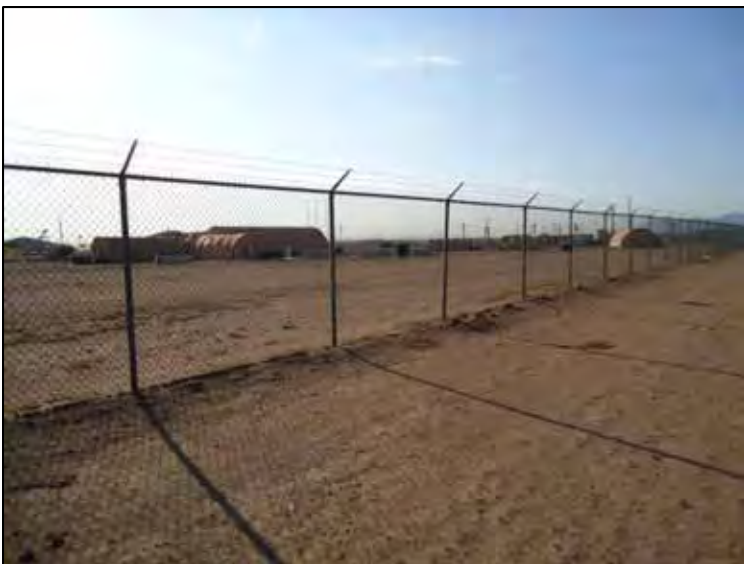
DP13: North portion used for Antiterrorism Security Operations (ATSO) training

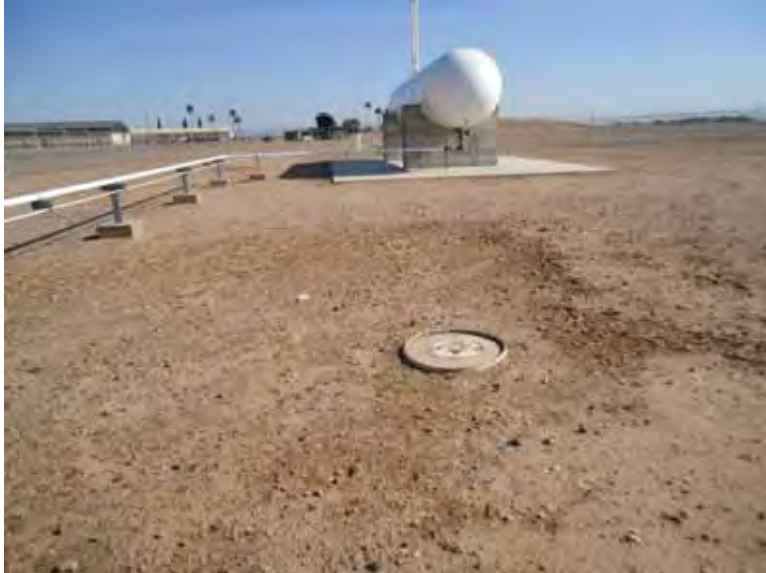
FT-07E: Monitoring well near propane tank at FT-07E

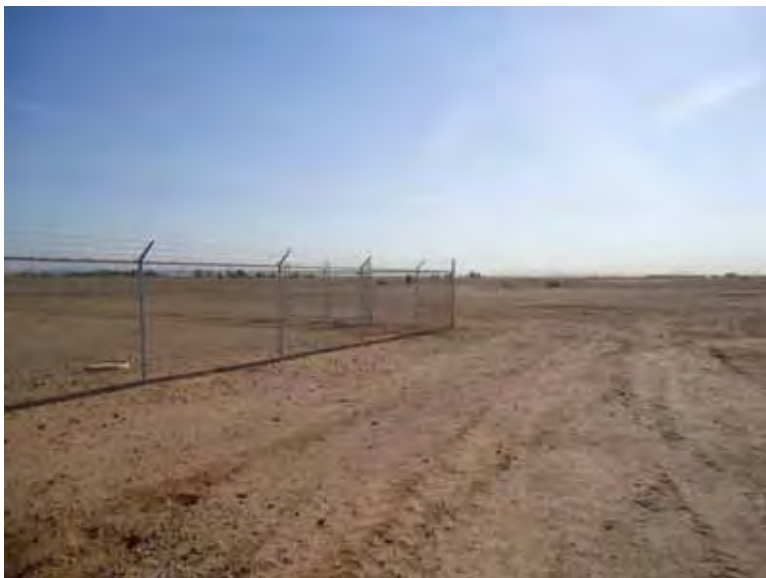
FT-07E: Looking east near the FT-07E monitoring wells.

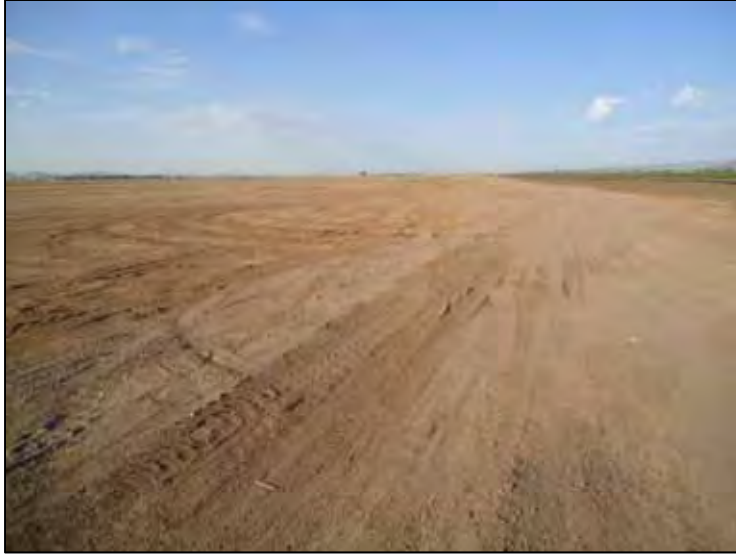
LF-03: Runway covers part of site,  
no clear indication/delineation of  
site boundaries.

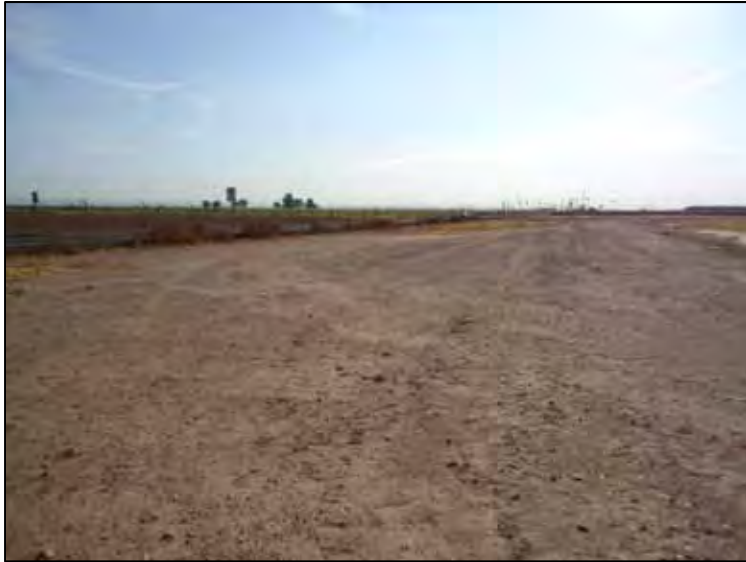
LF14: Looking east  
towards northeast corner  
of Base

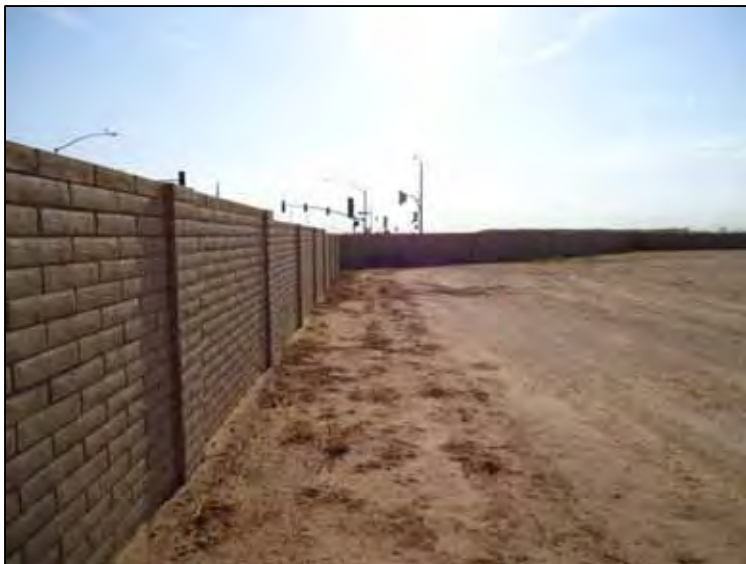
LF-14: Corner of  
Northern Avenue and  
Litchfield Road

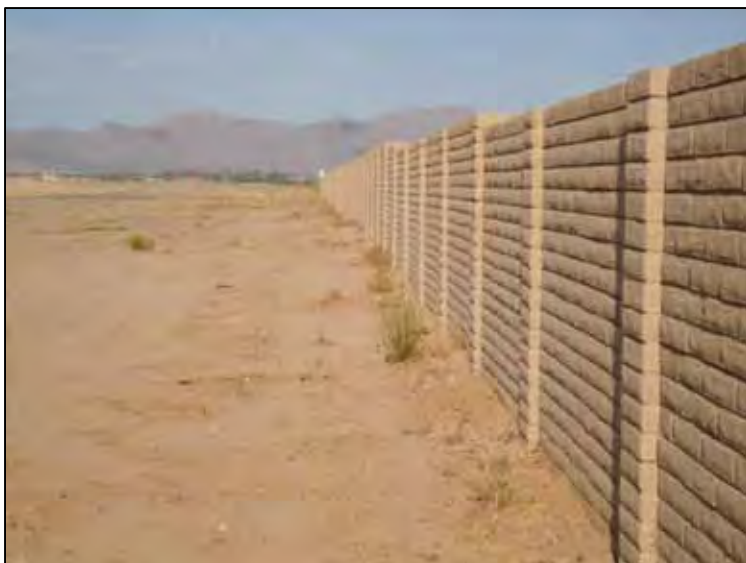
LF-14: Looking west  
parallel to Northern  
Avenue.

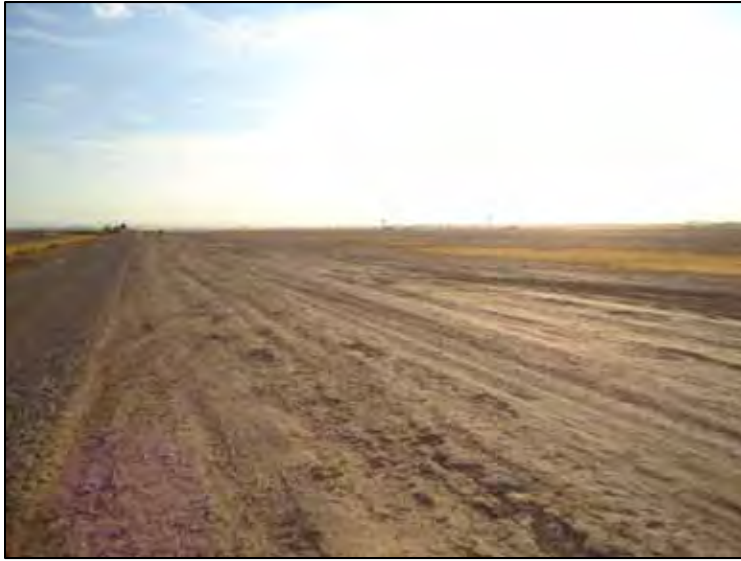
LF-25: Looking northeast, site access road has been recently repaved

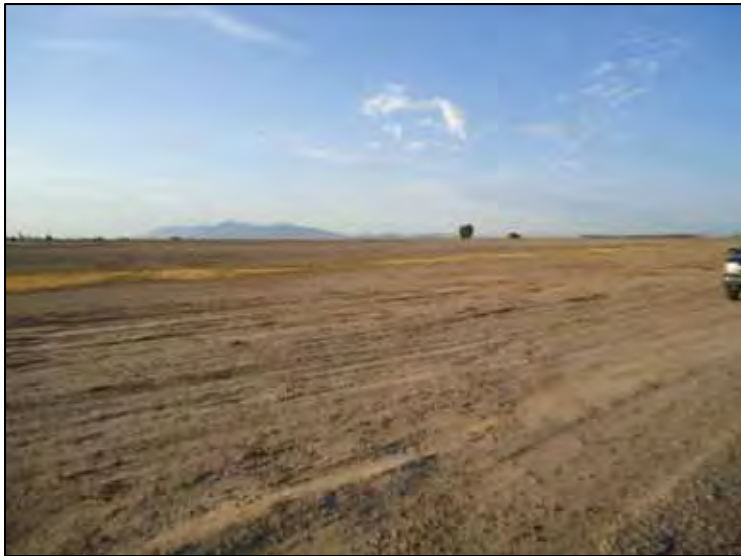
LF-25: Looking southwest, down dirt access road.

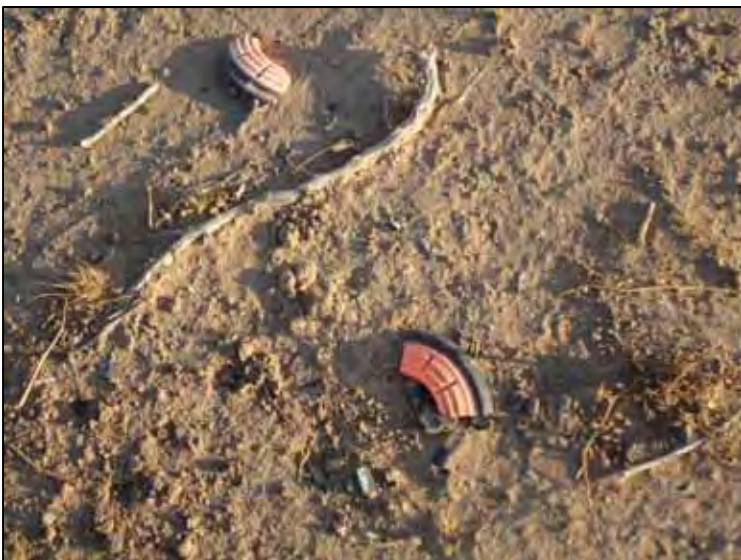
- **Ongoing Operations at Skeet Range Adjacent to LF-25:** Material from the adjacent skeet range continues to fall on LF-25. The remedy of ICs controls exist to control a worker's exposure during excavation at the site, not to prevent any ongoing impact to surface conditions from the adjacent skeet range. The remedy continues to be protective in controlling uncontrolled excavation at the site. However, the remedy was selected based on an assessment of surface conditions at LF-25 several years ago. During the next five-year review period, the Base will revalidate surface conditions at LF-25.

<b>1. SITE INFORMATION</b>	
Site Name: <b>LF-25 Northwest Landfill</b>	Inspection Date: 9/1/2011
Location: Luke AFB	EPA ID: AZ0570024133
Five-Year Review Lead: Luke AFB	Weather: Sunny
Remedy Includes: Institutional controls	
Attachments: See attached photos	
<b>2. INTERVIEWS</b>	
Alan Thomas, Restoration Manager, CES/CEAN	
<b>3. ON-SITE DOCUMENTS &amp; RECORDS VERIFIED</b>	
Not applicable; site described in OU-1 ROD	
<b>4. O&amp;M COSTS</b>	
Not applicable	
<b>5. ACCESS &amp; INSTITUTIONAL CONTROLS</b>	
Basewide security, area itself is fenced, signed VEMUR to restrict future use to non-residential; LF-25 is listed in Base General Plan and Institutional Control Plan; AF Form 332 submitted prior to any onsite development or construction, will trigger notification of the Restoration Program Manager	
<b>6. GENERAL SITE CONDITIONS</b>	
Site is adjacent to active Base Skeet Shooting Range; some debris from range was observed during site inspection.

LF-25: Example of material from adjacent Base Skeet Shooting Range.

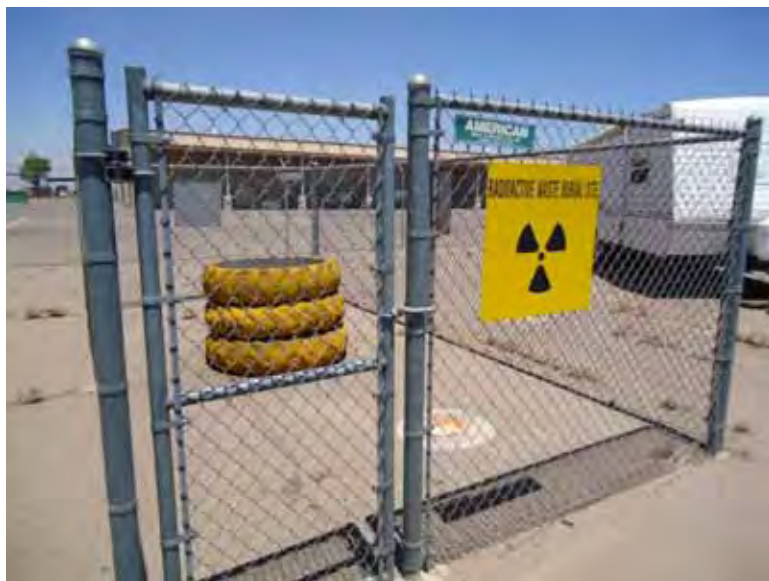
RW-02: Institutional controls at radioactive waste burial area.

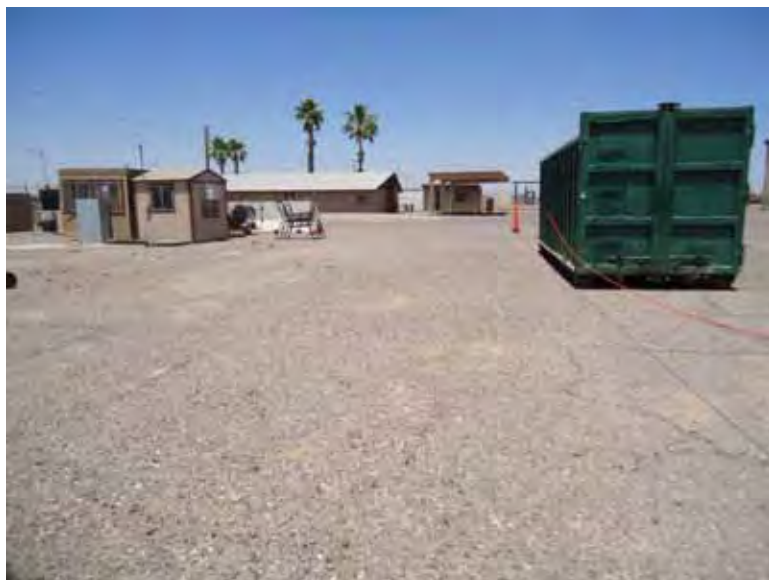
RW-02: Area near monitoring wells at RW-02

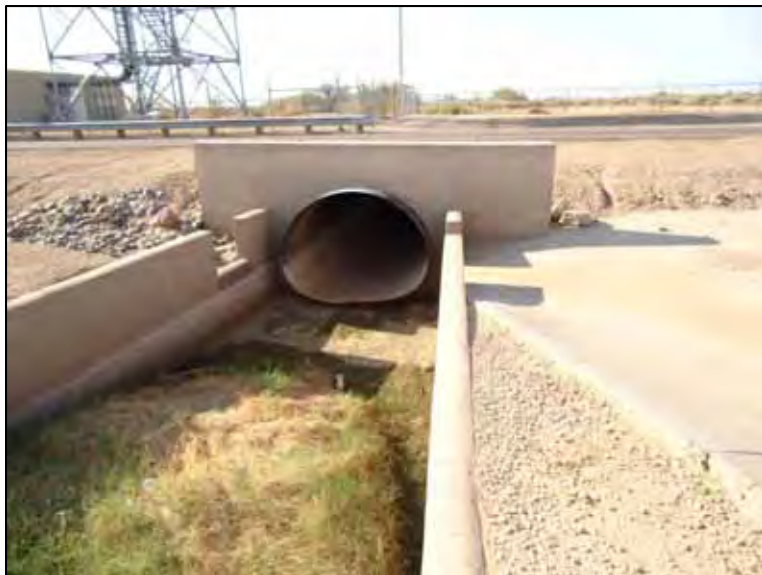
SD-20: Culvert on south side of Super Sabre.

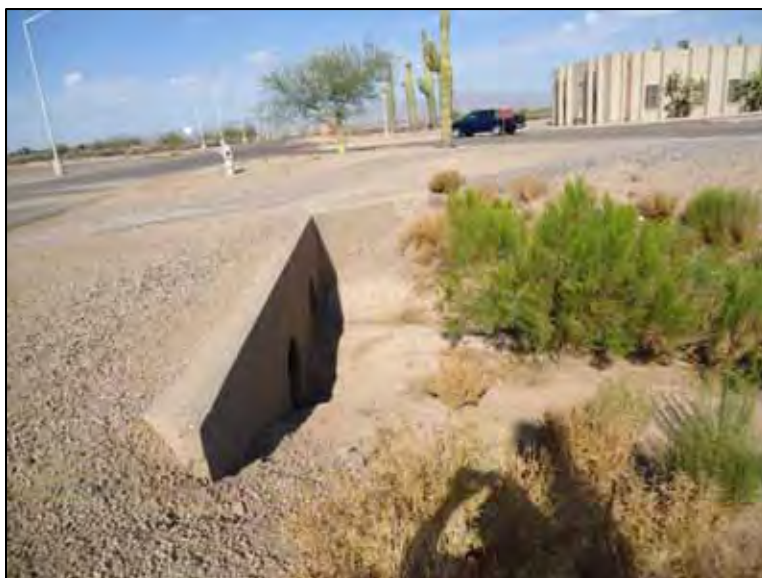
SD-20: Near Ammo Country administrative building.

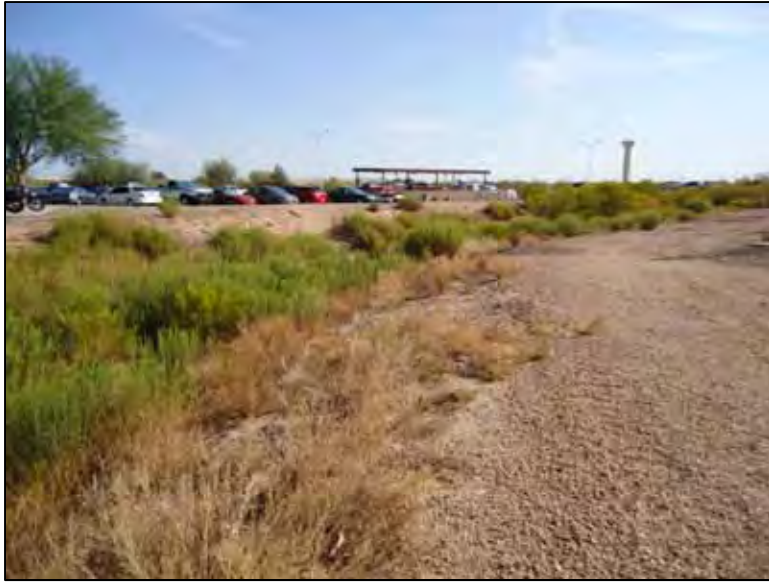
SD-20: North end of  
drainage channel

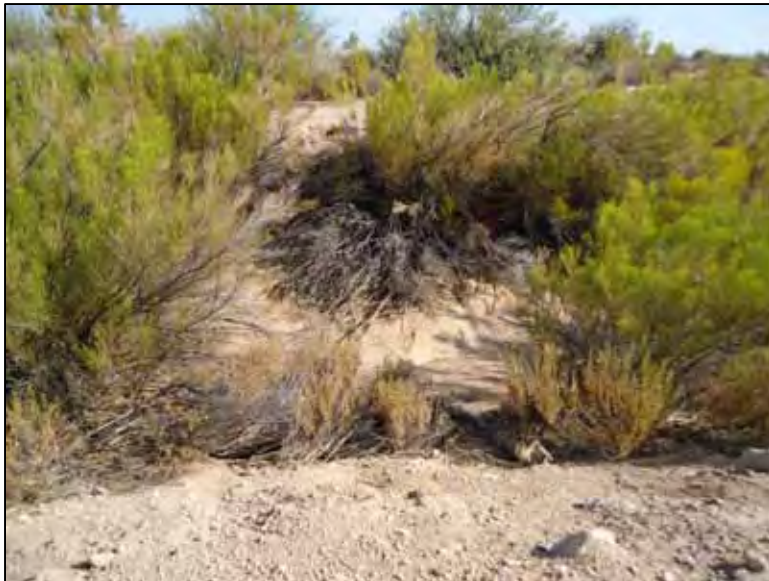
SD-20: Example of  
vegetation lining side of  
drainage channel

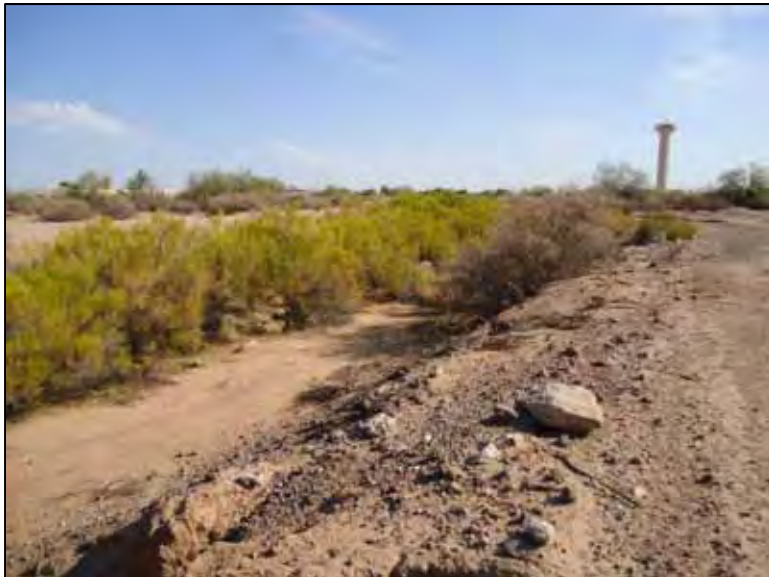
SD-20: Looking north  
towards Base

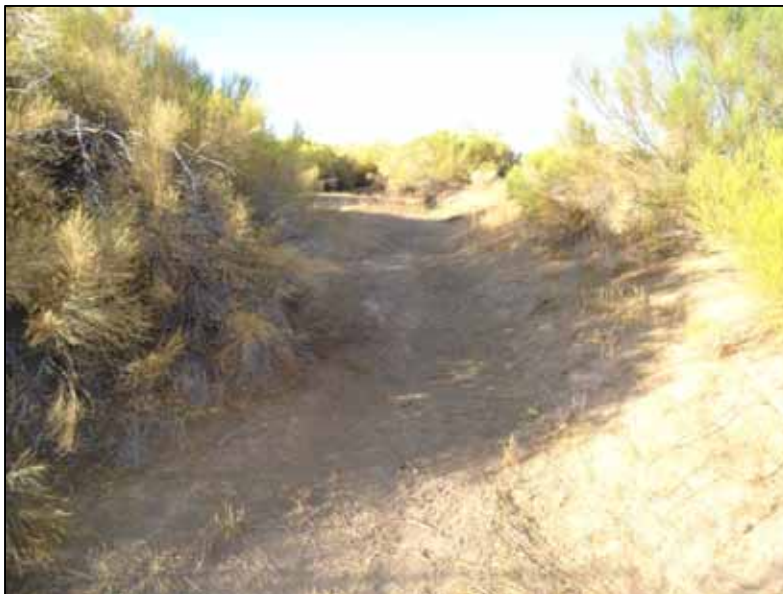
SD-20: Example of  
vegetation.

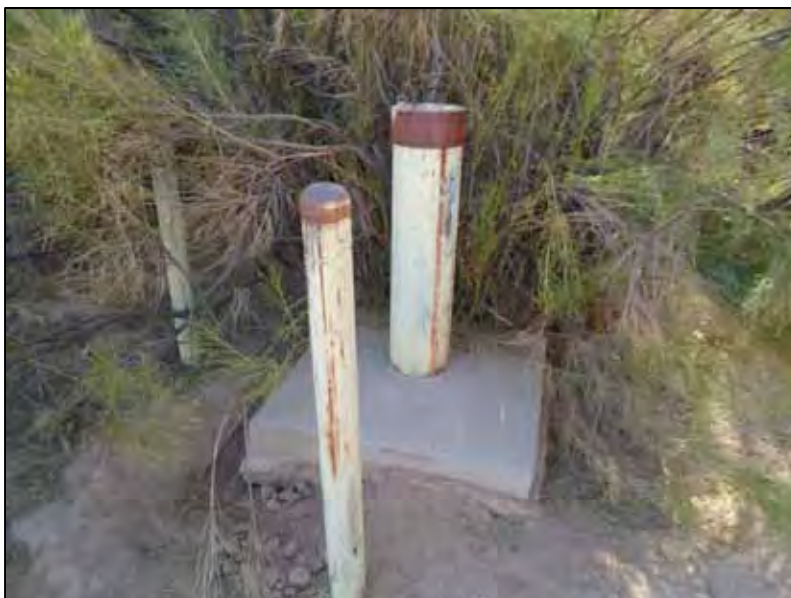
SD-20: Standpipe  
monitoring well and  
ballards

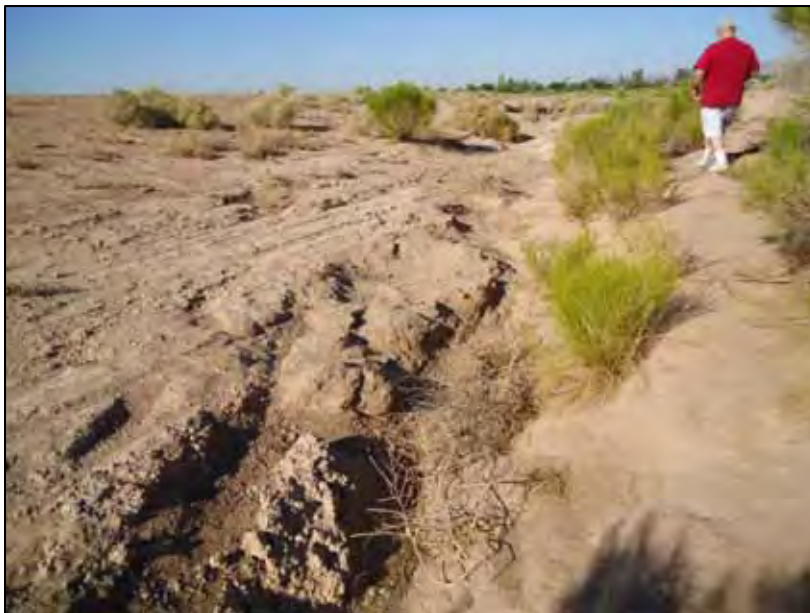
SD-20: Southern end of  
drainage channel

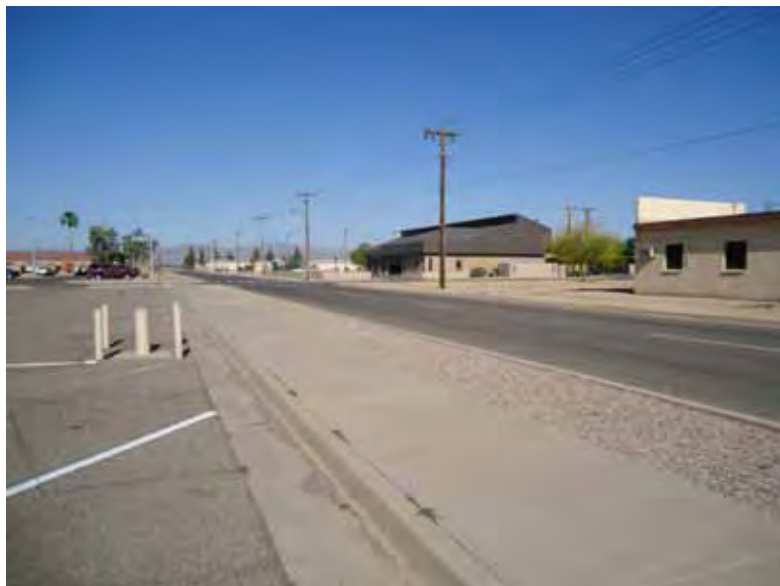
SD-38: Looking across street to location of the former auto body shop

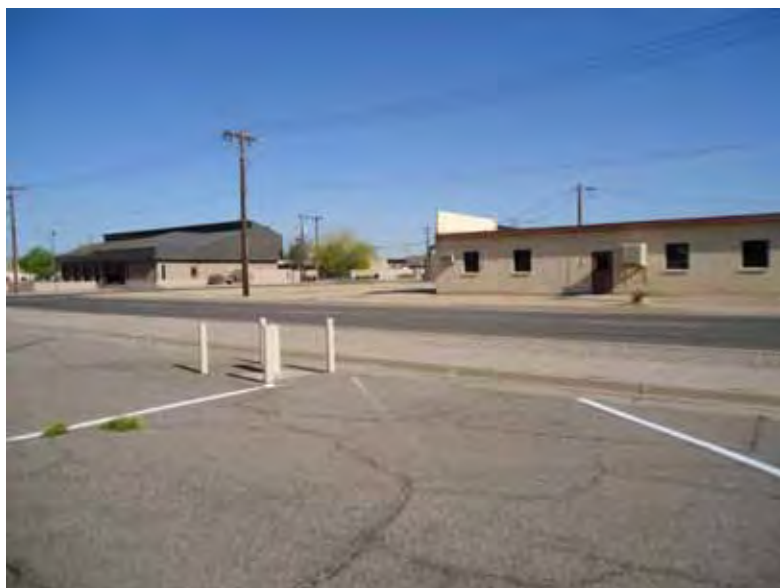
SD-38: Monitoring well by site SD-38.

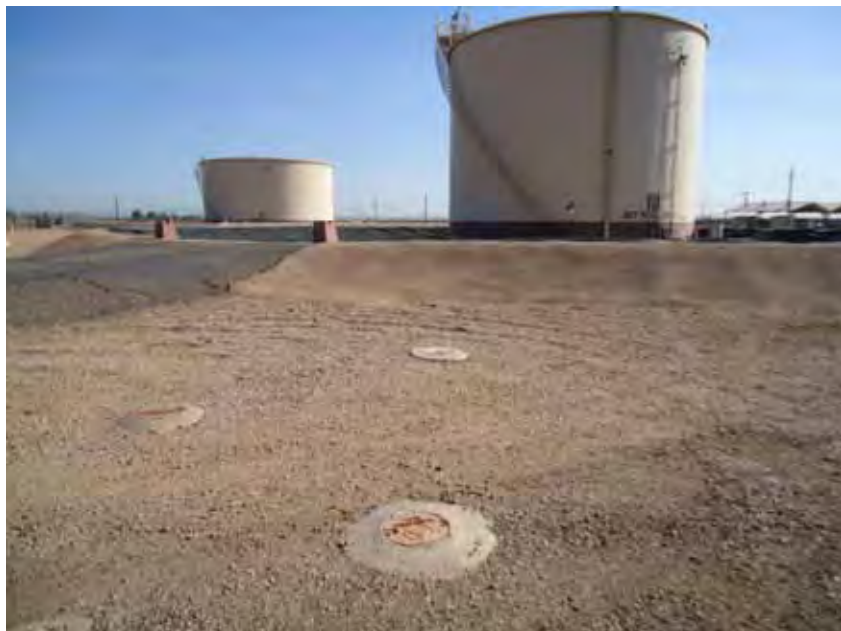
SS-42: Bulk fuels storage facility with secondary containment around the aboveground storage tanks

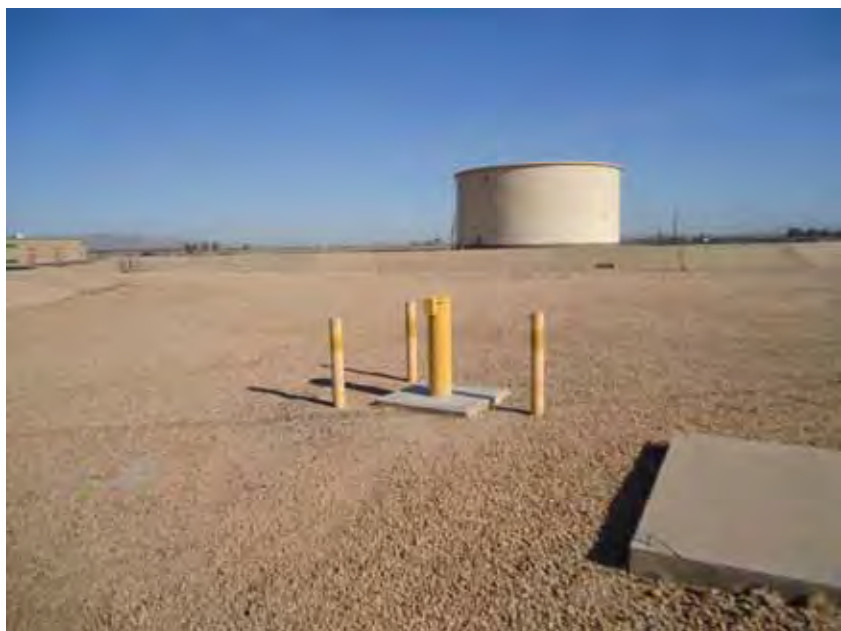
SS-42: Monitoring wells at site SS-42

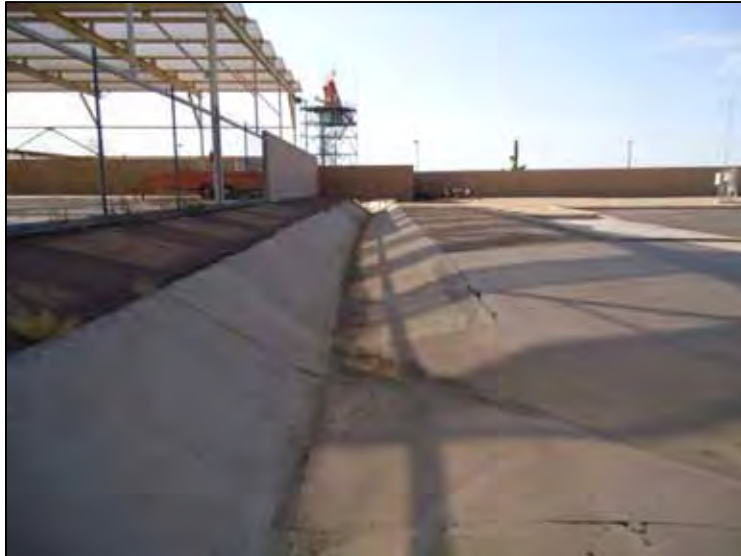
DP-23: Drainage channel near  
DP-13 area.

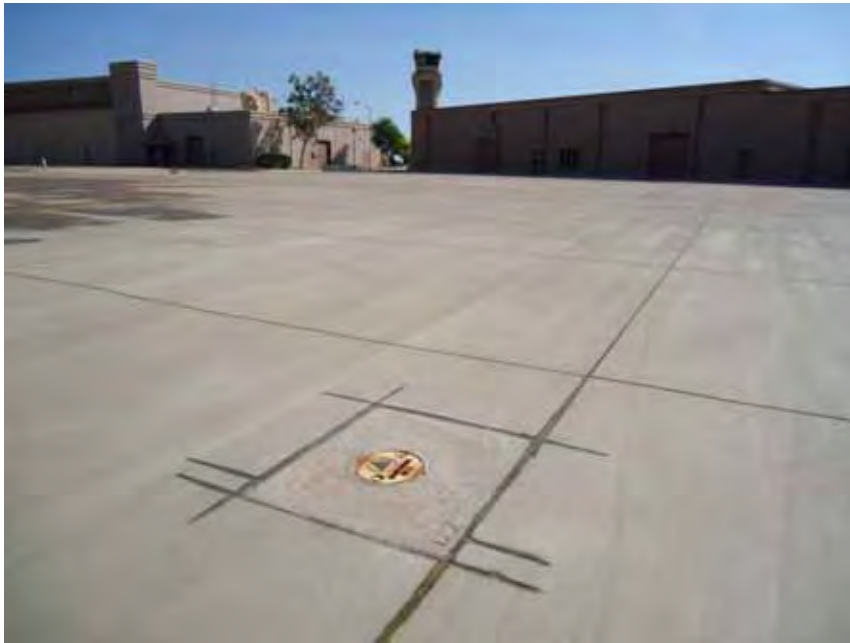
ST-18: Monitoring well at ST-18 area, looking towards Bldg 993

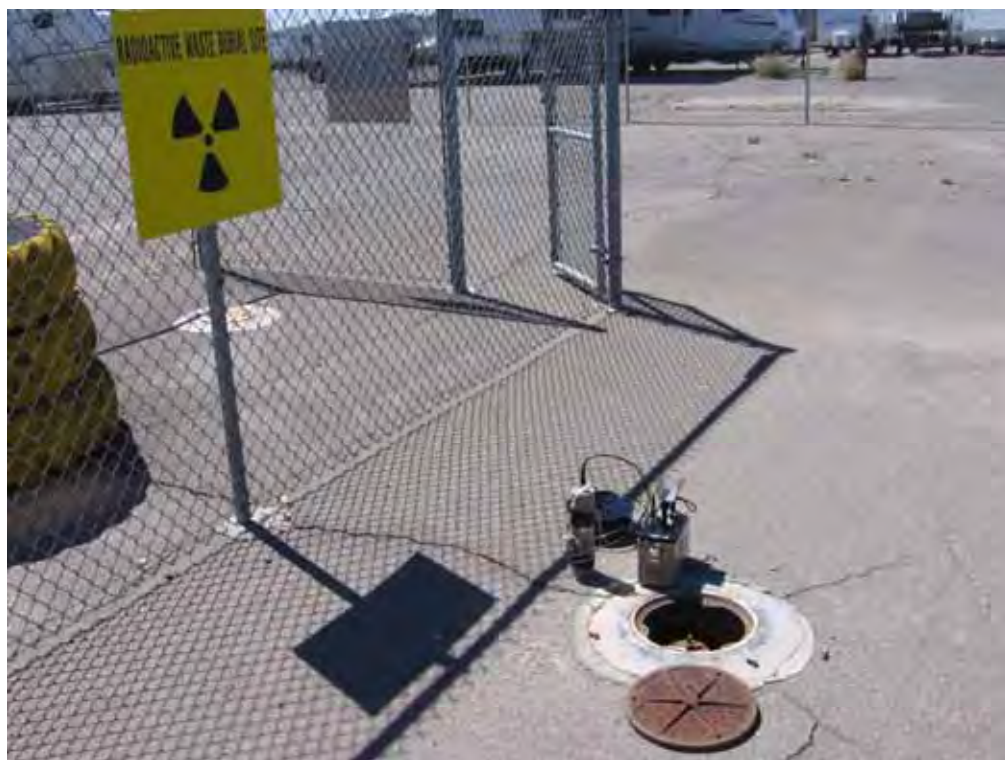
Photograph 2: The Ludlum Model 2221 portable scaler/ratemeter and Model 44-10 scintillator probe next to monitoring point MP-4.

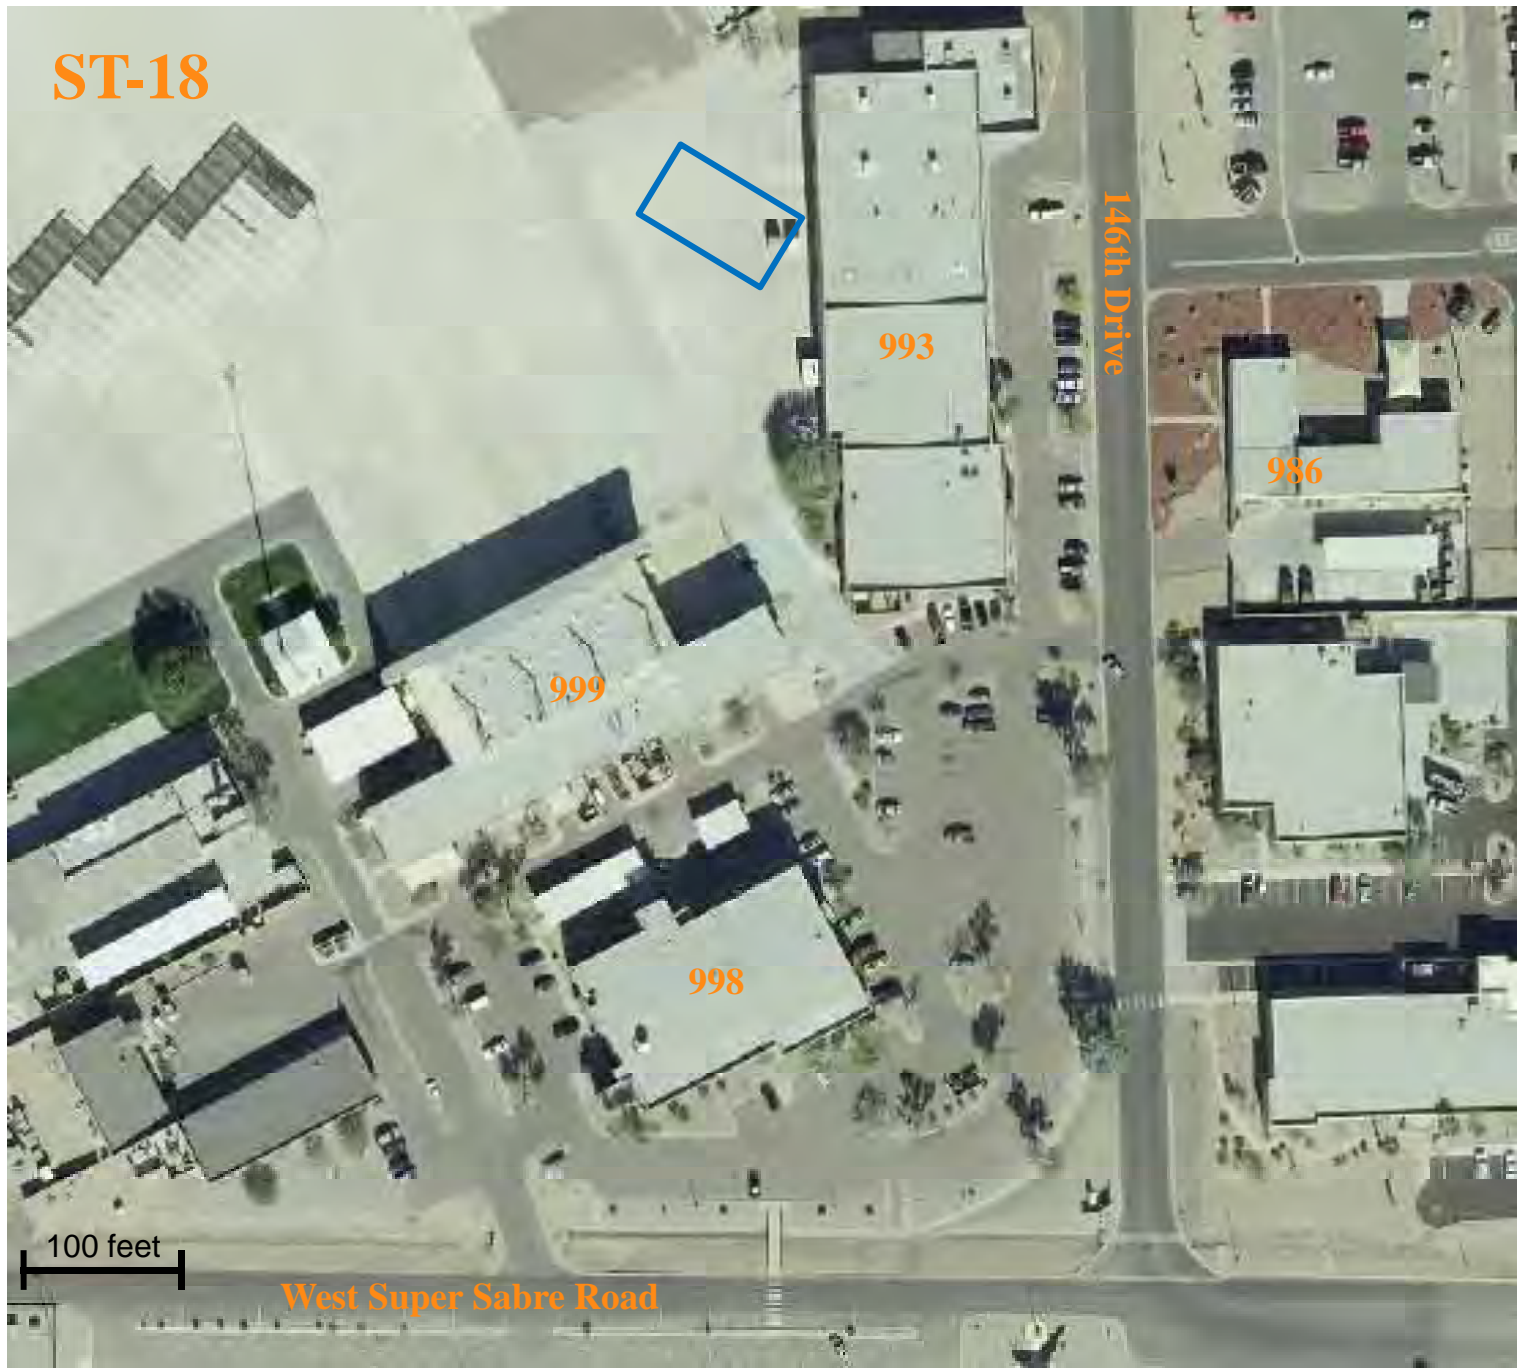
**Figure E-1**

Site ST-18 was capped with concrete in 1987 as part of the RCRA post-closure requirements for Luke AFB. The cap was installed as a means to control access to, and contaminant migration from, soils that may have been impacted by releases from the three former USTs located west of Building 993. The OU-2 ROD documents the cap as the selected remedial action and describes the requirements for inspection, maintenance, and repair of the concrete cap. According to design data provided by Luke AFB, the cap consists of a 30-millimeter high density polyethylene (HDPE) liner covered by six inches of aggregate base, and a nine-inch thick reinforced-concrete cap. Figure E-1 presents a site map of the ST-18 area.

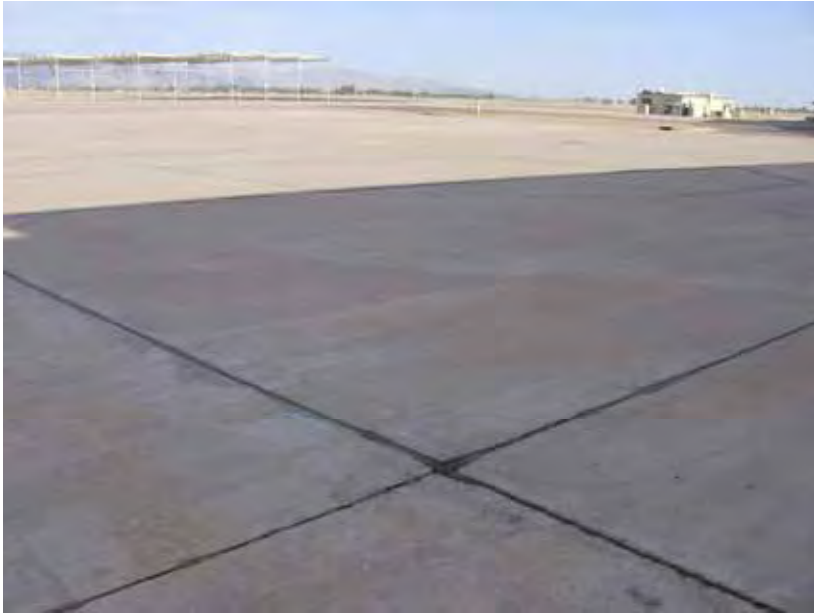
The results of the inspections indicated that the concrete cap appears to be stable, without noticeable buckling or differential settlement. Significant vertical displacement was not observed during the inspections at cracks or expansion joints. There were no unusual cracking patterns to suggest heaving or settlement in the soil below the cap. Scaling of the cap surface area was not observed. A small rust stain was observed within the cap area; however, the surface did not appear to have been impacted by chemical degradation. The inspections specifically targeted visual observation of joints, cracks, and previous repairs as these locations represent the most likely potential routes of minor surface water infiltration.

Photograph 1: Start of one of the transects walked during the 2009 cap inspection; standing next to Building 993 looking west across the cap.
